# ORD Problem Solved!

## Compression Set

### O-Ring Failure

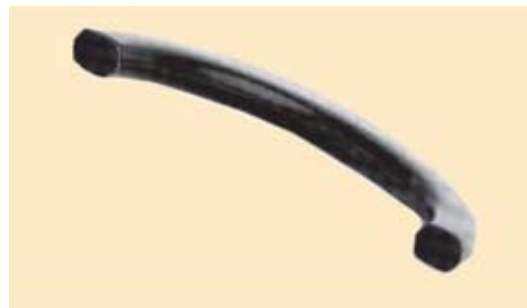
Characteristic compression set - high deformation seen as flattening on all contact surfaces.

Compression set is a term referring to the flattening or loss of the original, circular shape on all contact surfaces of an elastomeric seal. As one of the most common causes of o-ring failure, compression set can be attributed to various conditions, such as excessive squeeze, incompatible fluid, improper gland design and gland overfill (see Failure Analysis table below). However, the most common cause is a low quality elastomer with poor set resistance.

Failure Analysis - Top Causes for Compression Set Leakage	
1.	Selection of O-ring material with inherently poor compression set properties.
2.	Improper gland design, particularly gland overfill condition
3.	Excessive temperature causing the o-ring to lose its elastic properties. (High temperatures may be caused by system fluids, external environmental factors or frictional heat build-up).
4.	Volume swell of the o-ring due to system fluid.
5.	Excessive squeeze due to over tightening of adjustable glands.
6.	Introduction of fluid incompatible with o-ring material.
